IL PERCORSO CLINICO
DEL PAZIENTE CON PROTESI
VALVOLARE, VALVOLE
ARTIFICIALI PERCUTANEE

MILANO, Atahotel Executive
28 - 29 Ottobre 2010

STUDIO DELLE PROTESI CON ECOCARDIOGRAFIA TRANSTORACICA E TRANSESOFAGEA *(la scelta della finestra, i metodi di studio, i tranelli)*

Dr. Manuela Muratori

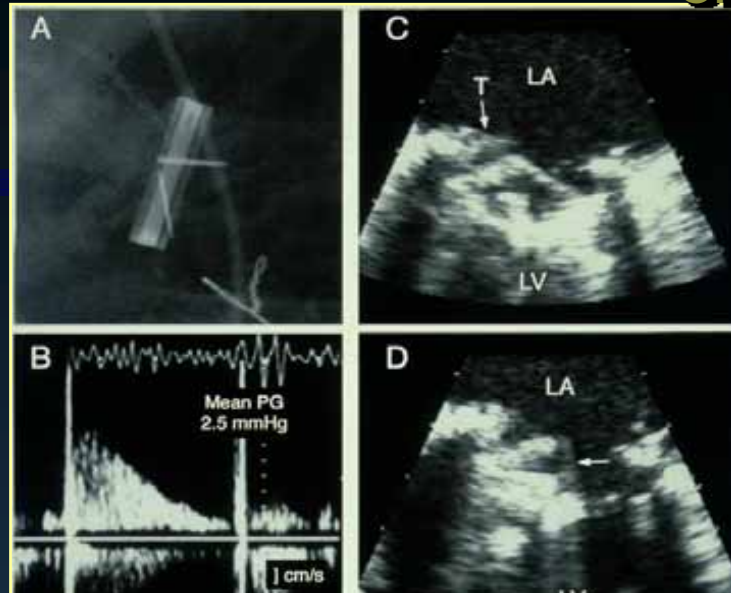
Carbomedics Mitral Prosthesis

- CF +
- Doppler: Normal DP
- TEE: thrombus +

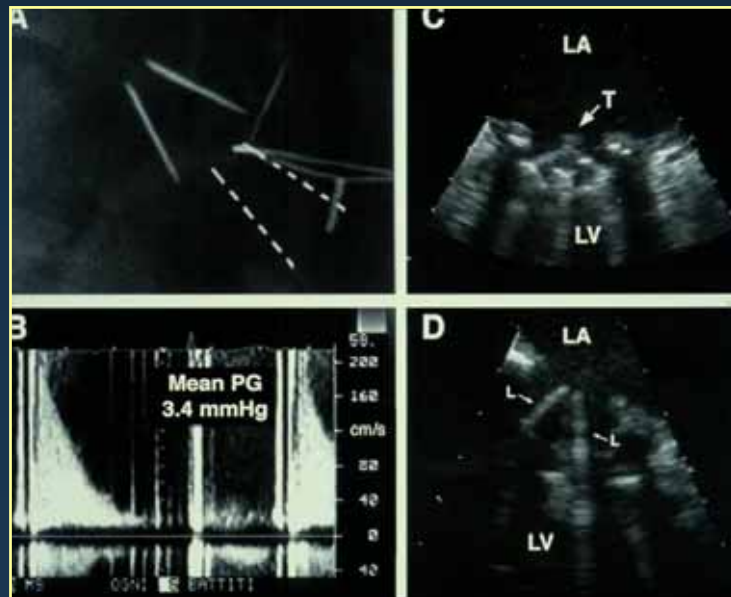
St Jude Mitral Prosthesis

- CF slightly +
- Doppler: Normal
- TEE: small thrombus

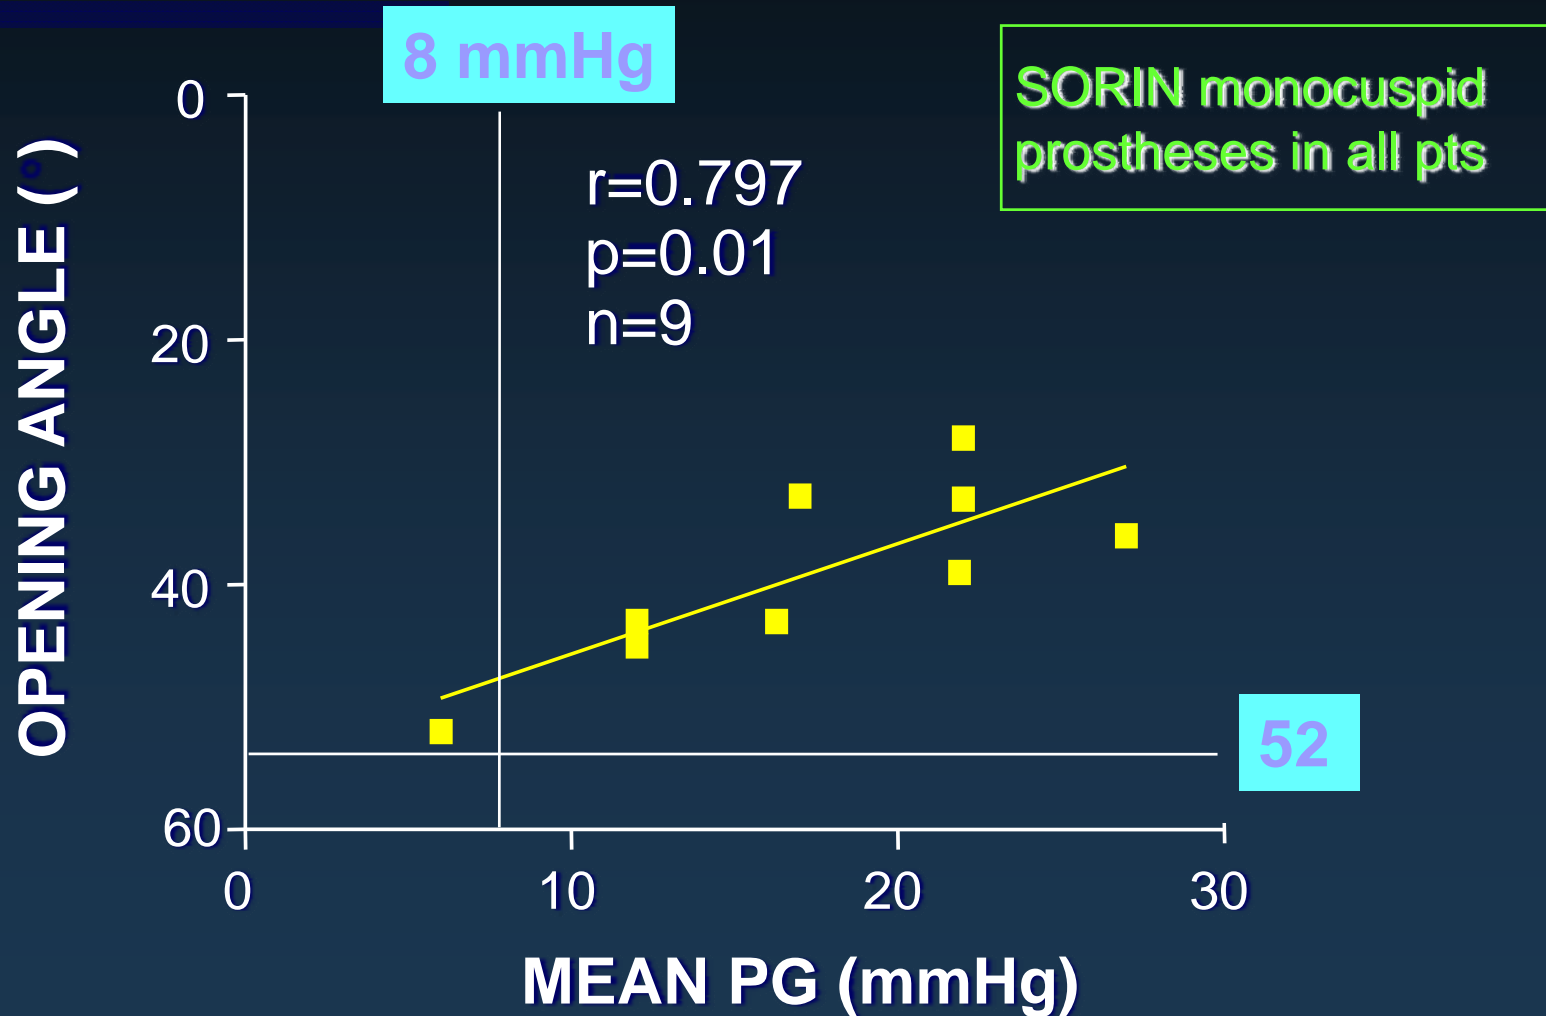
PROSTHETIC MITRAL VALVE THROMBOSIS

EFFECT OF PROSTHESIS TYPE ON DOPPLER GRADIENT

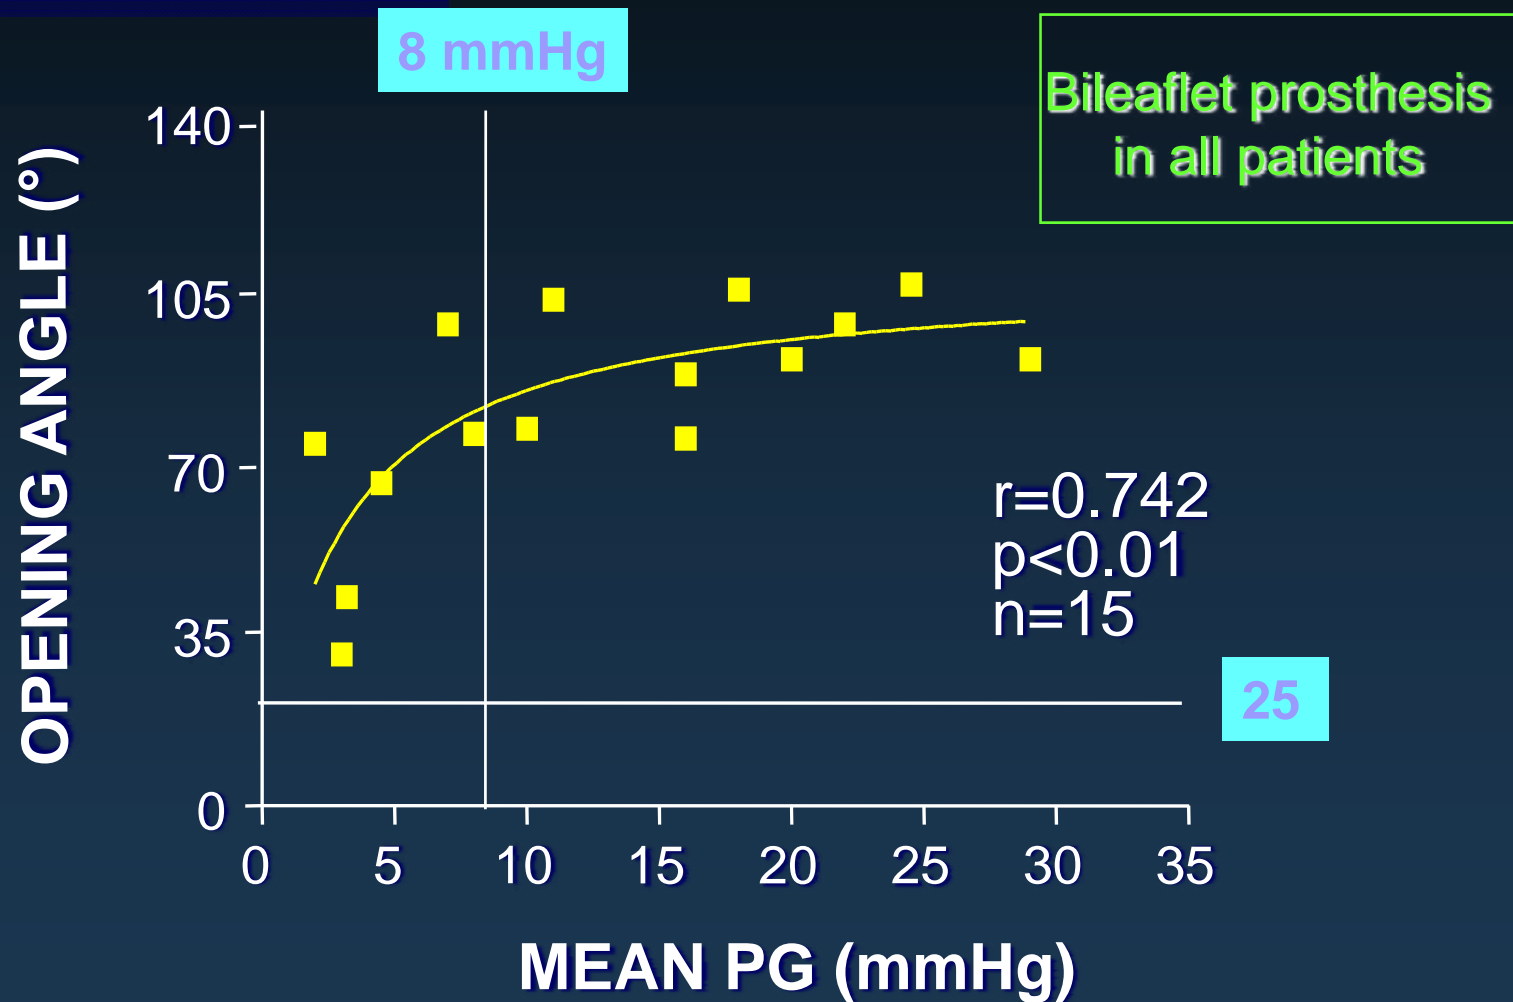
PROSTHETIC MITRAL VALVE THROMBOSIS

EFFECT OF PROSTHESIS TYPE ON DOPPLER PRESSURE GRADIENT

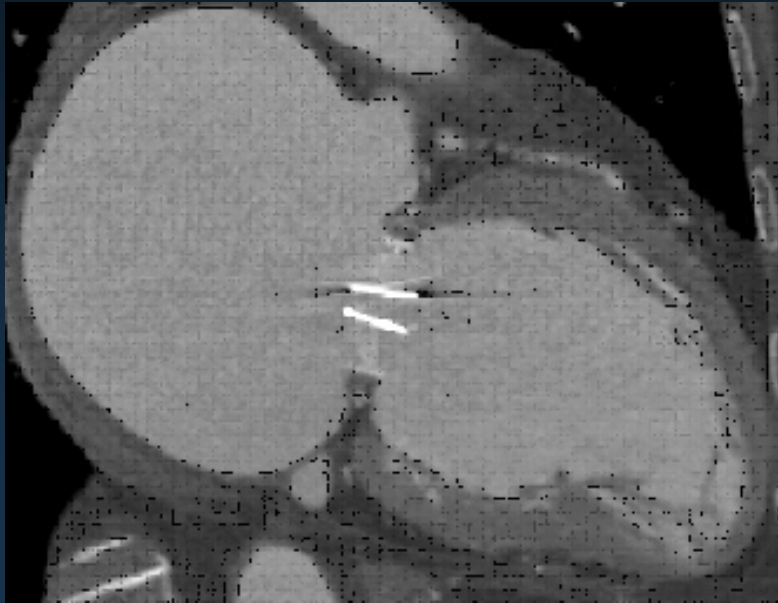
Protesi mitralica

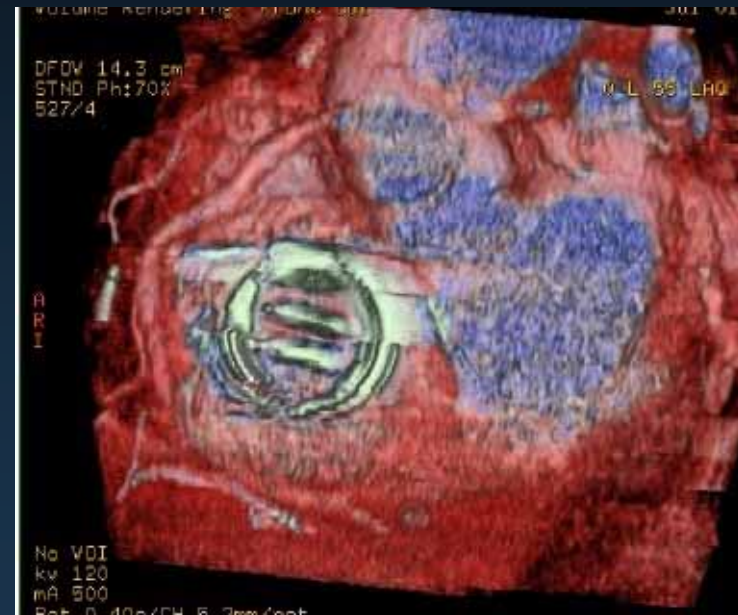
Protesi tricuspidalica

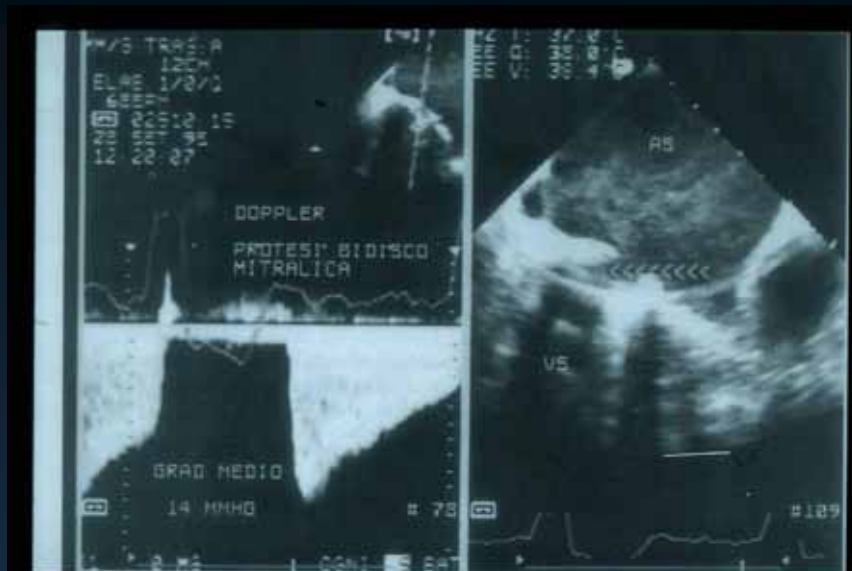
TROMBOSI INTRAPROTESICA
MITRALICA

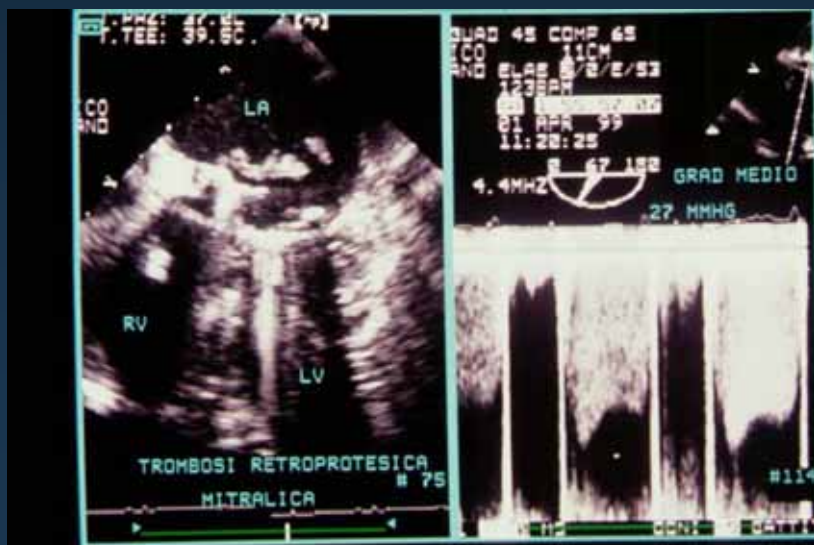
TROMBOSI RETROPROTESICA
MITRALICA

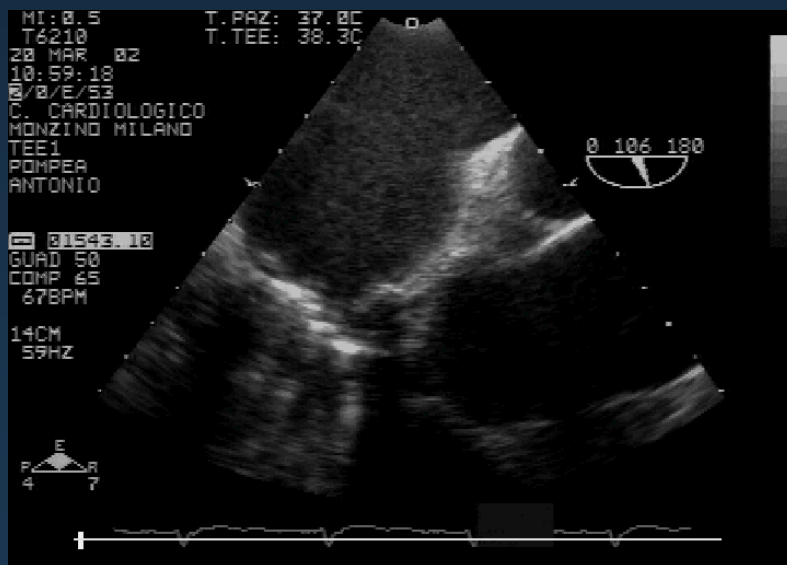
TROMBOSI IN PROTESI BIDISCO

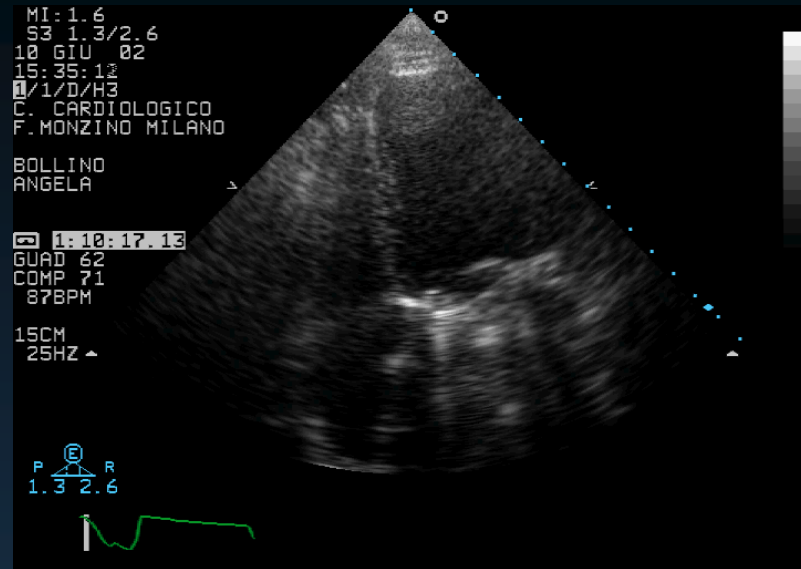
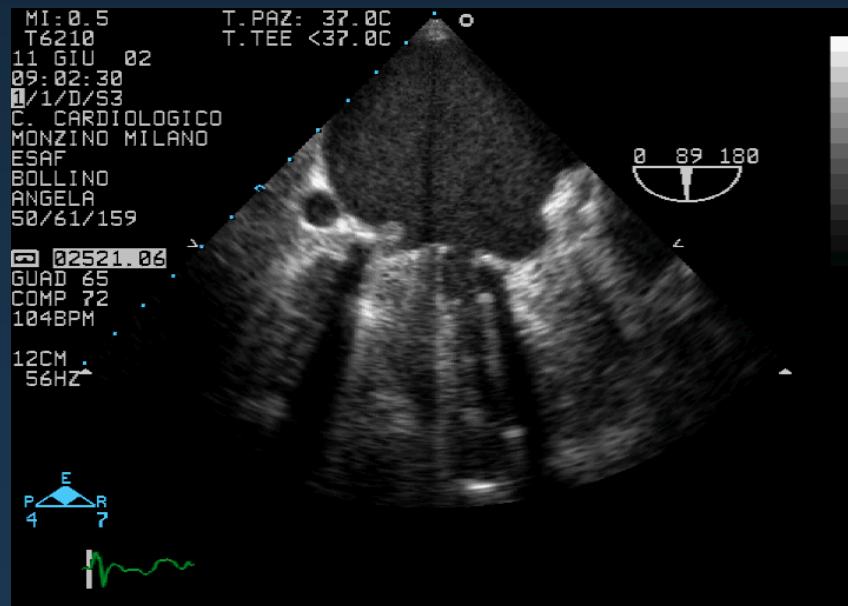
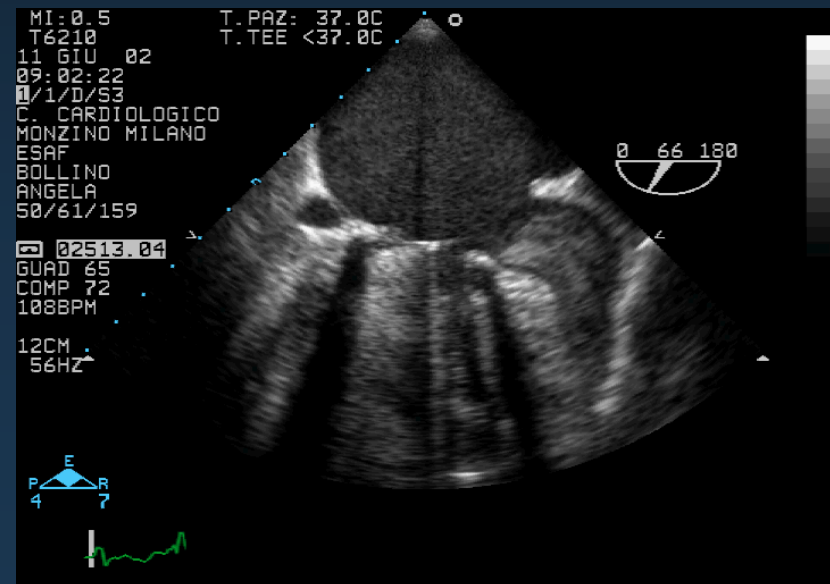
A.B. 50 y, Sorin 29. INR 1,2. Mean Gradient: 12 mmHg;
PHT 261 msec

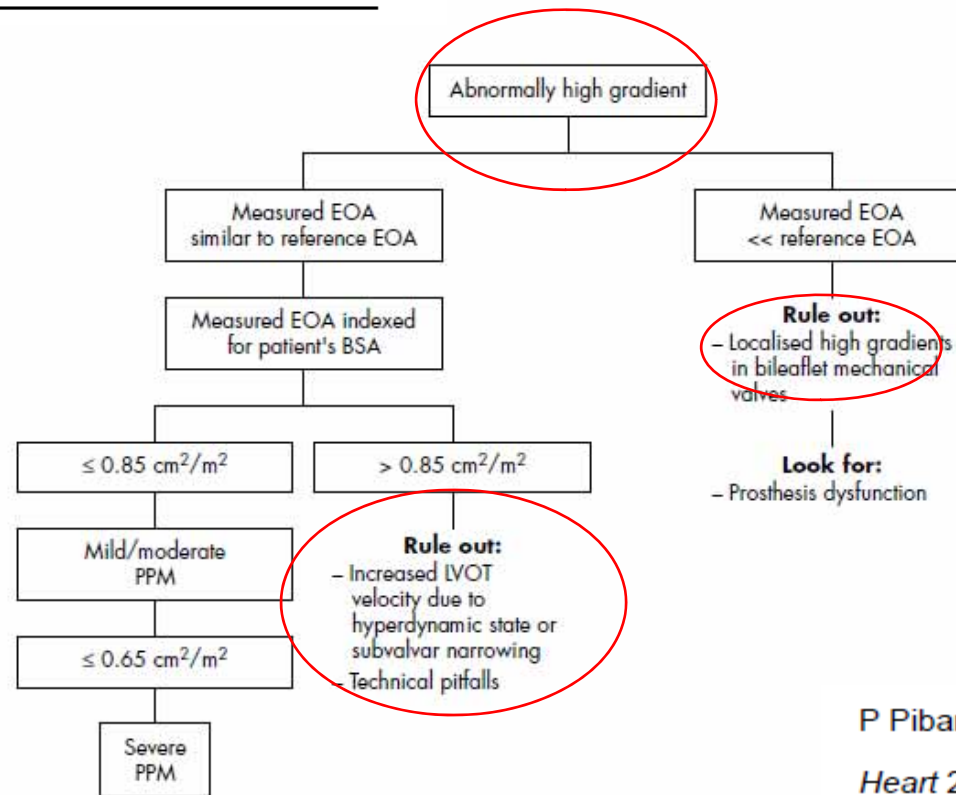
Figure 7 Algorithm used for evaluating abnormally high transvalvar pressure gradients after aortic valve replacement. LVOT, left ventricular outflow tract; PPM, prosthesis-patient mismatch. Reproduced and modified from Dumesnil and Pibarot⁴⁵ with permission from Marcel Dekker Inc.

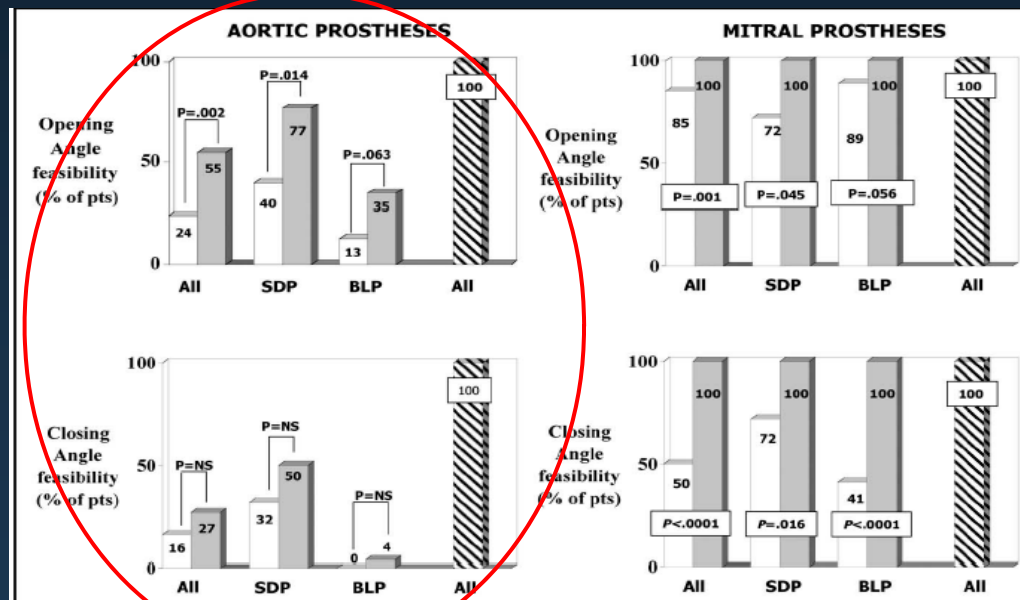
Figure 3. Feasibility of opening angle and closing angle measurements of TTE (white bars), TEE (gray bars), and cinefluoroscopy (dashed gray bars) in aortic and mitral prostheses. BLP = bileaflet prosthesis; SDP = single-disk prosthesis.

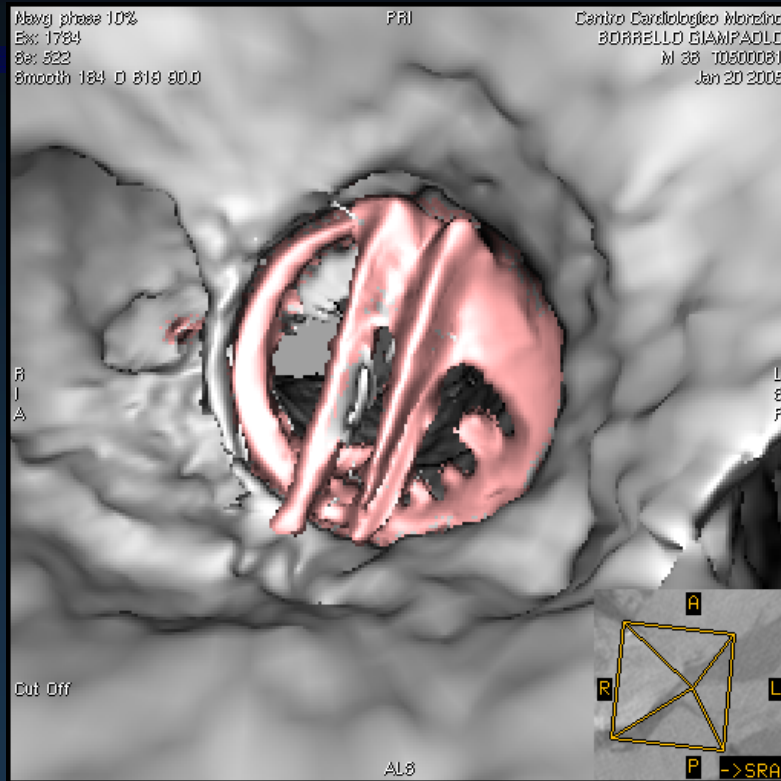
Dall'aorta ascendente

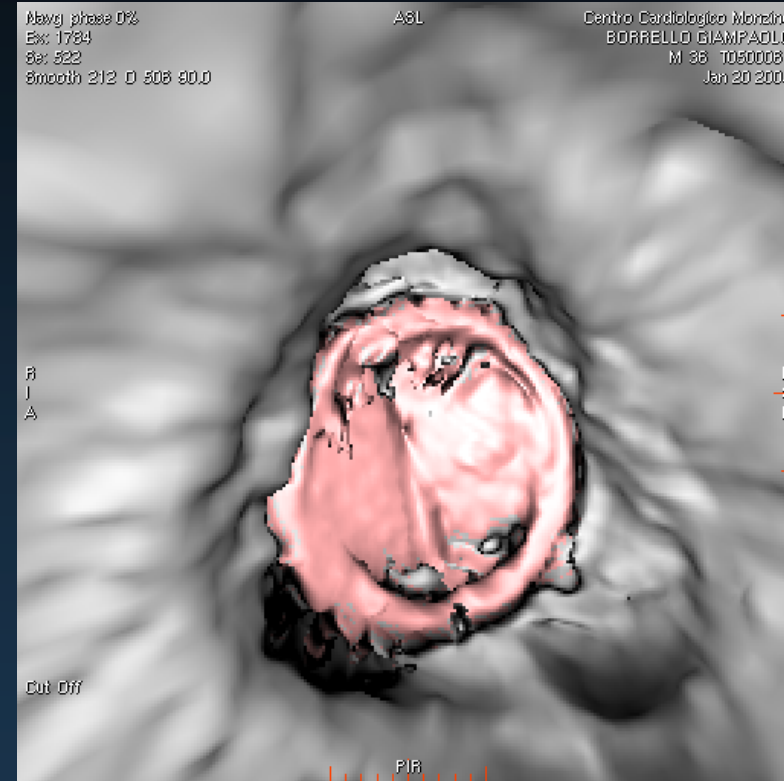
Dal tratto di efflusso VS

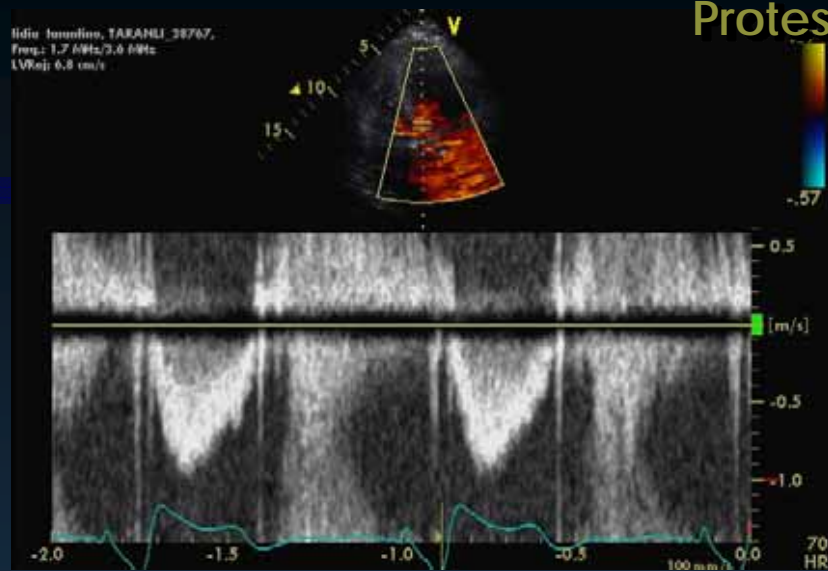
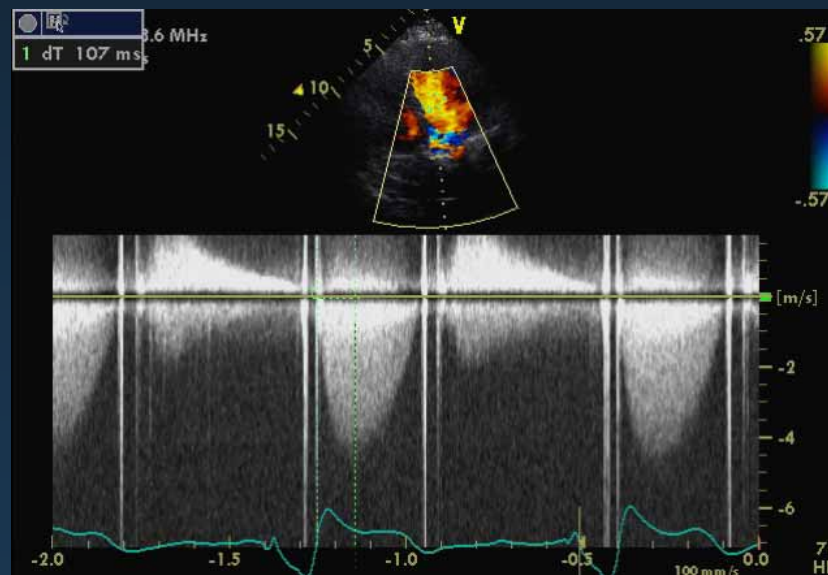
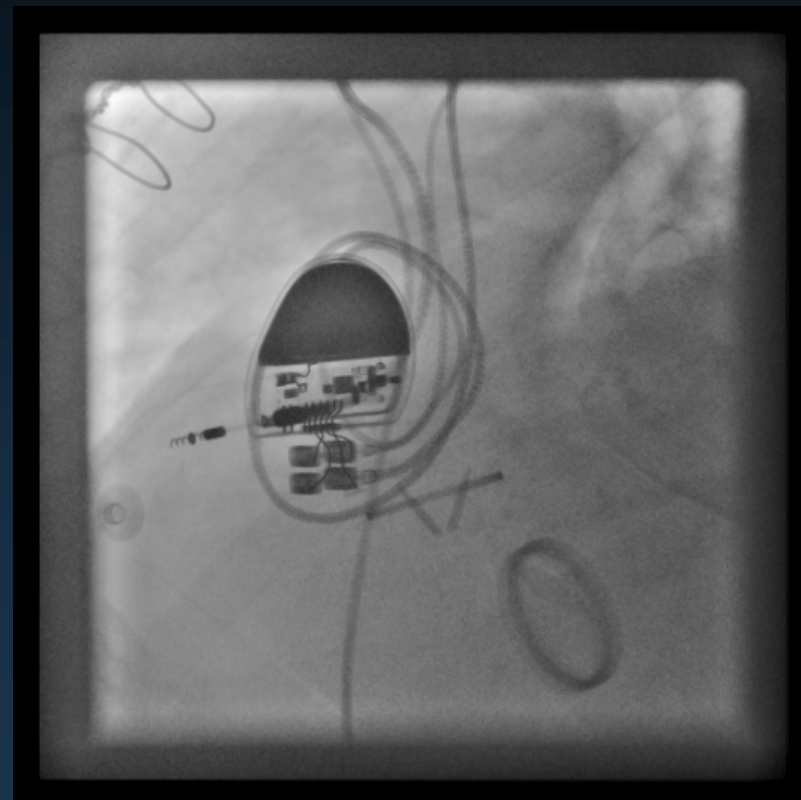
Carbomedics 21: DVI 0,21; AT 107 msec

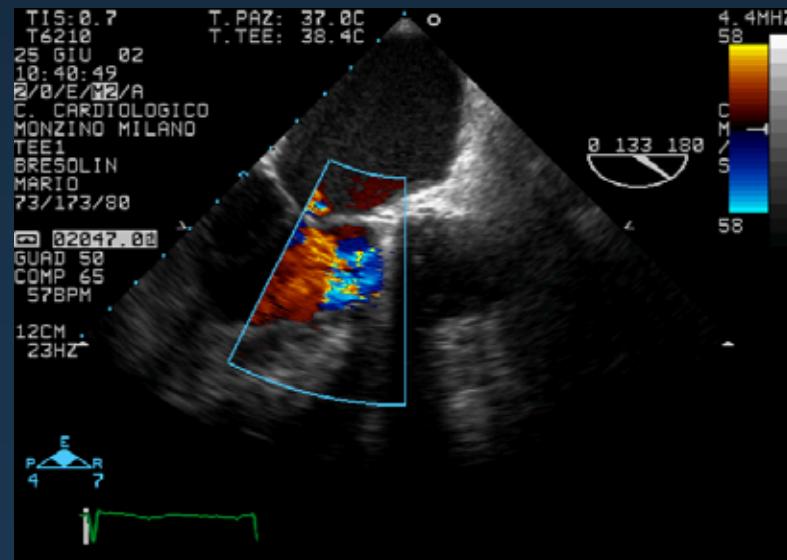
B.M. 73 y, Sorin 21. INR 1,2. NYHA III. Mean Gradient: 76 mmHg

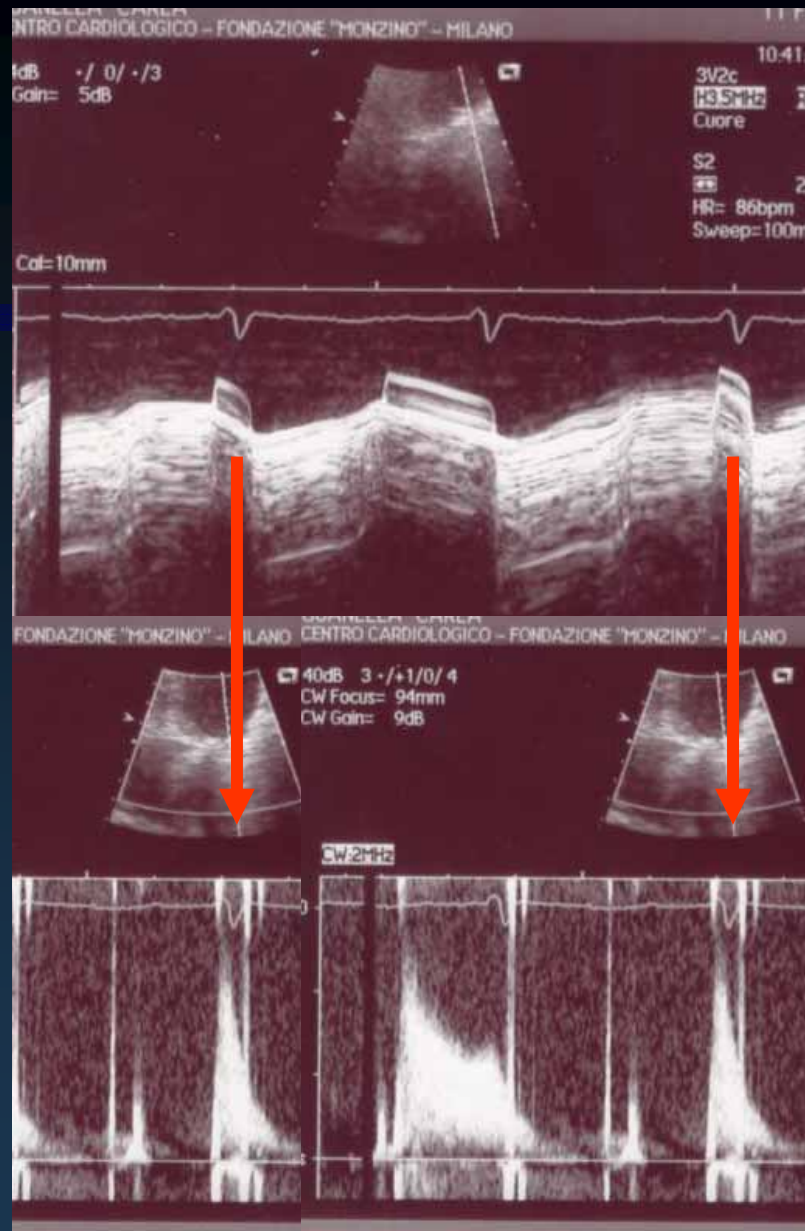
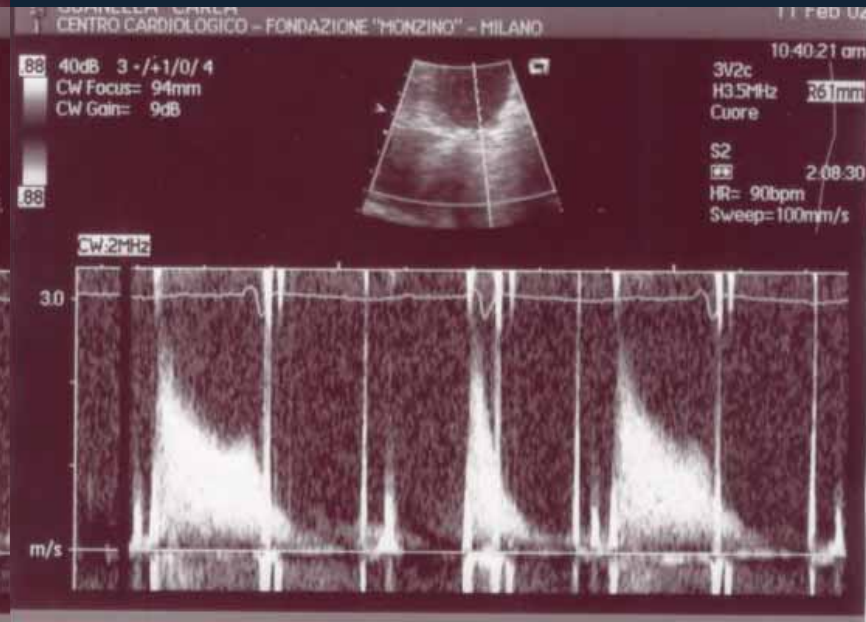
Intermittent opening in
Sinus Rhythm (end-
diastolic opening)

M-Mode e Doppler

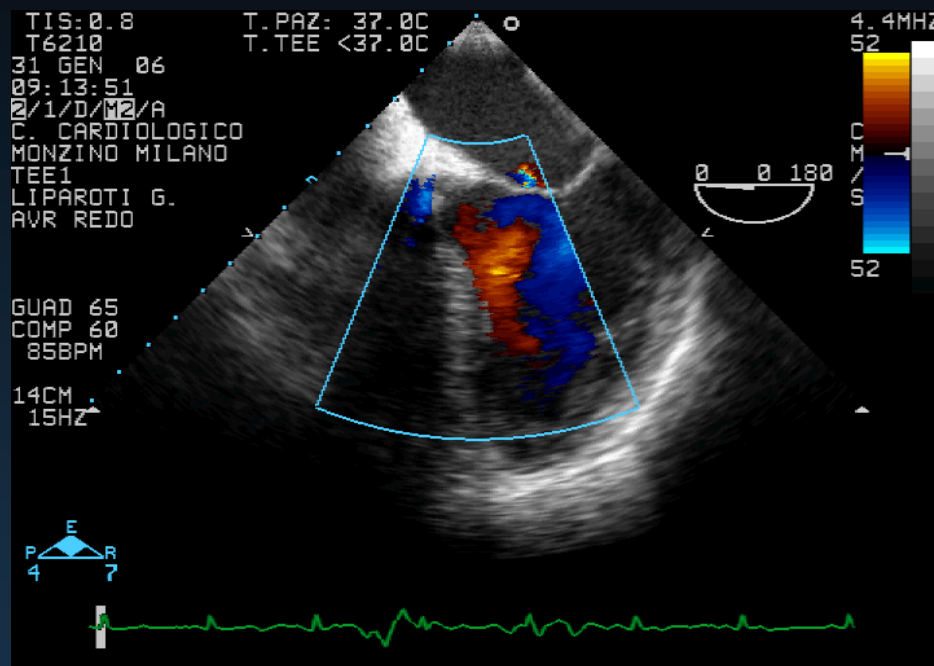
PANNO IN PROTESI AORTICA

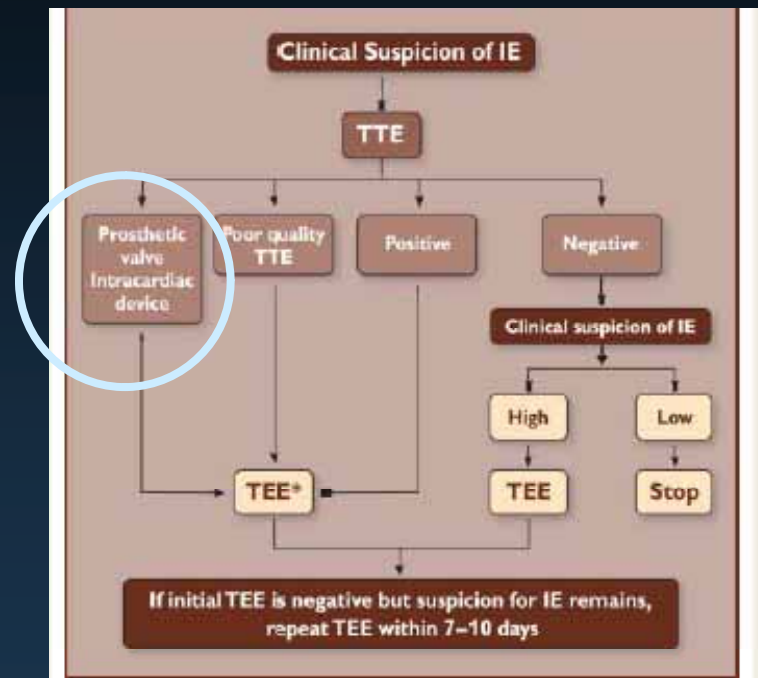
Figure 1 Indications for echocardiography in suspected infective endocarditis. IE = infective endocarditis; TEE = transoesophageal echocardiography; TTE = transthoracic echocardiography. *TEE is not mandatory in isolated right-sided native valve IE with good quality TTE examination and unequivocal echocardiographic findings.

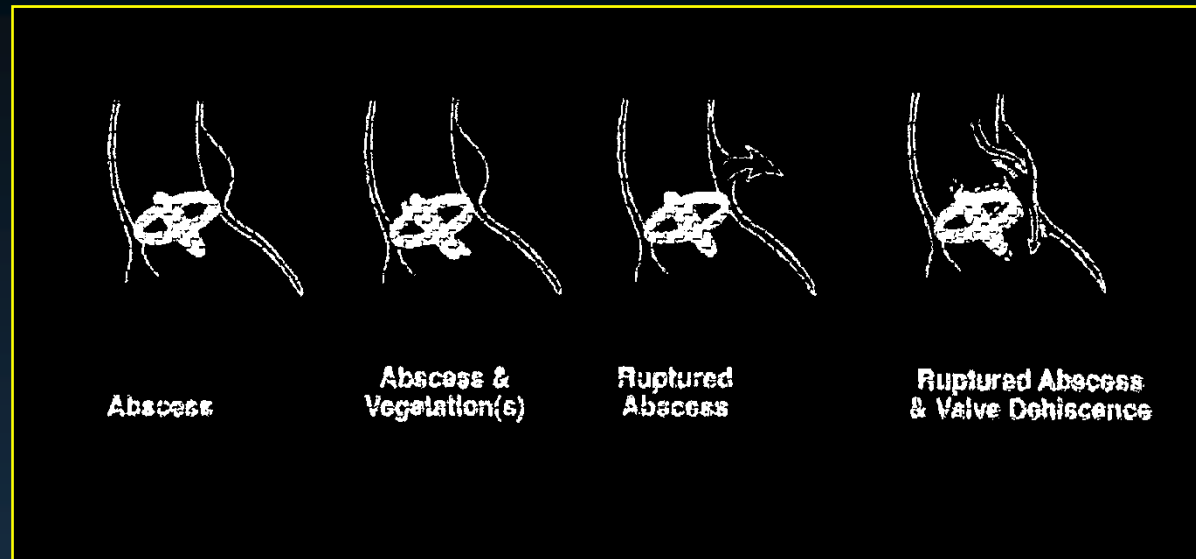
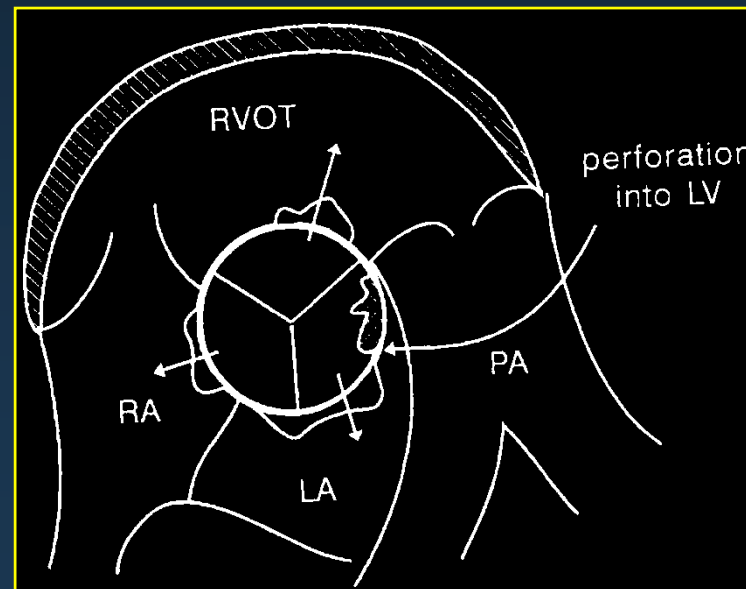
Ascesso periprotetico aortico

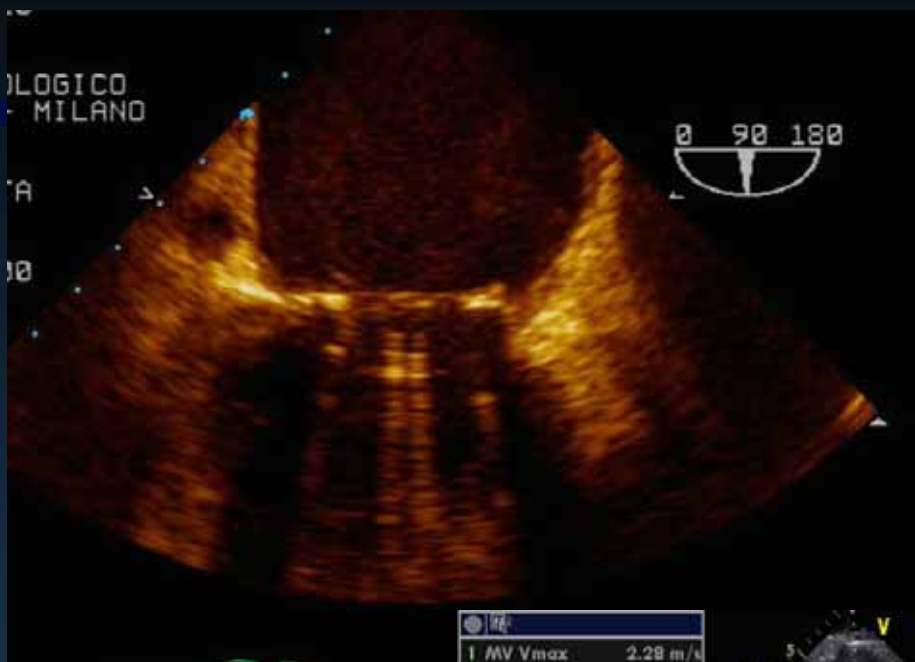
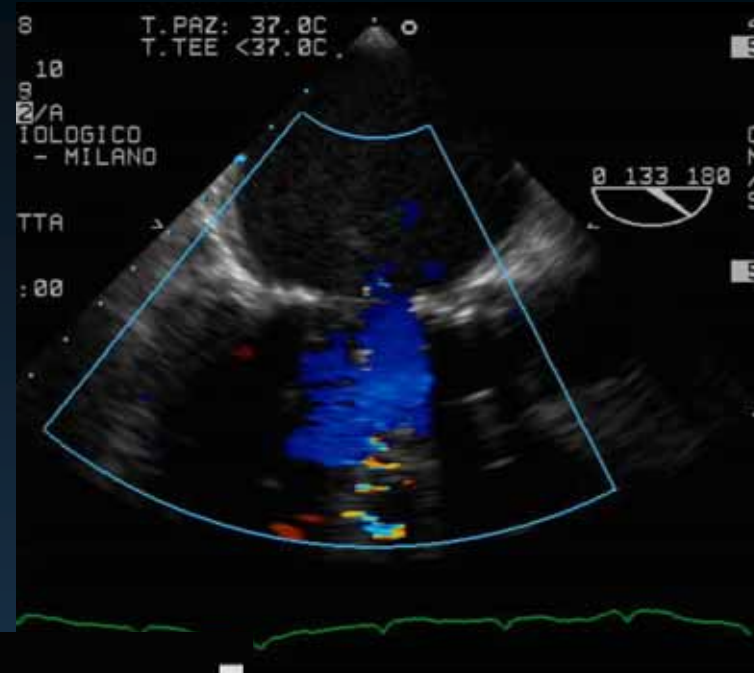
MV Vmax	2.28 m/s
MV Vmean	1.30 m/s
MV maxPG	20.88 mmHg
MV meanPG	8.26 mmHg
MV VTI	49.8 cm
