Ecocardiochirurgia.

*Il percorso clinico del paziente con protesi valvolari
e valvole artificiali percutanee*

**La RM puo' darci qualche elemento in piu' nel
sospetto di malfunzionamento protesico ?**

Alberto Roghi

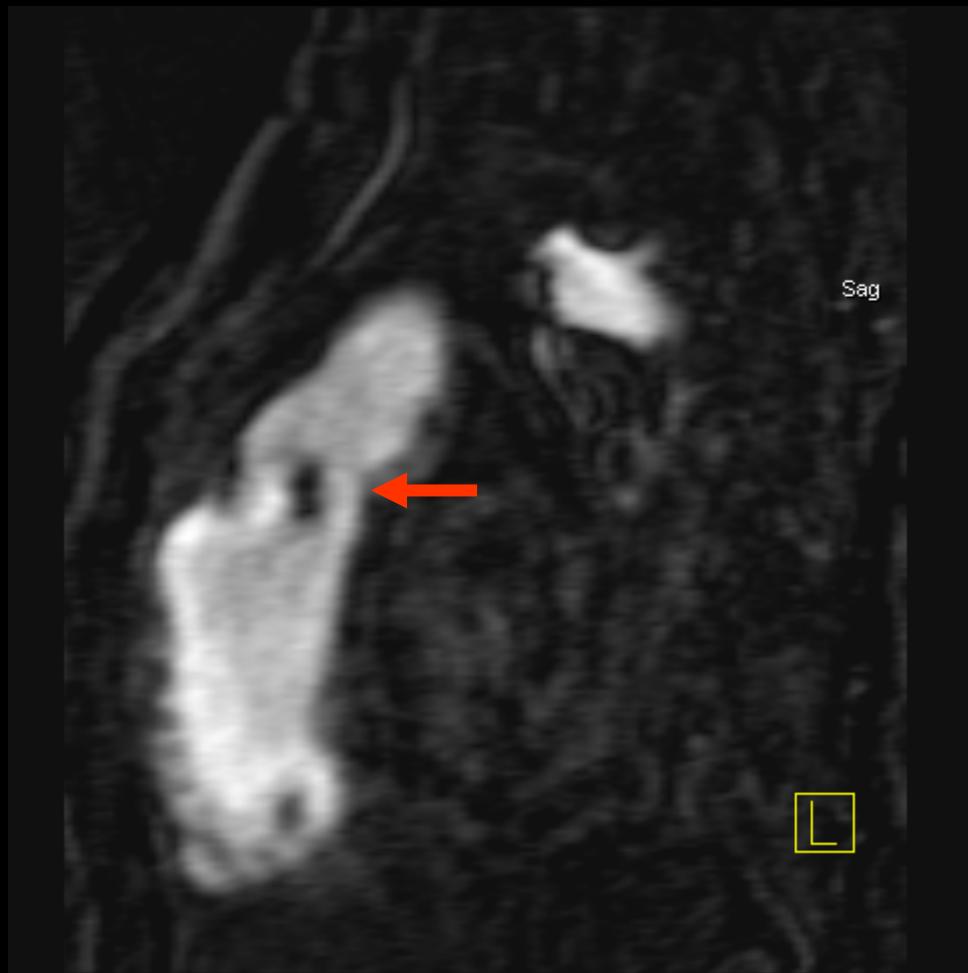
Pulmonary angiography, 2D Maximum Intensity Projection reconstruction:
posterior pulmonic bioprosthesis dehiscence

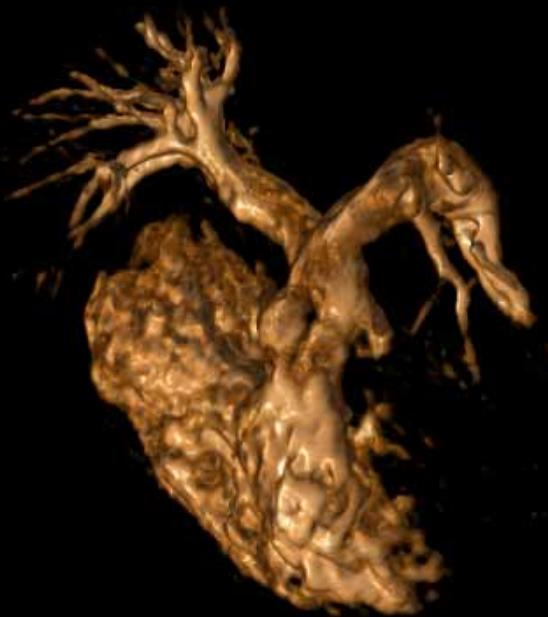
3D angiography, paraprosthetic leakage

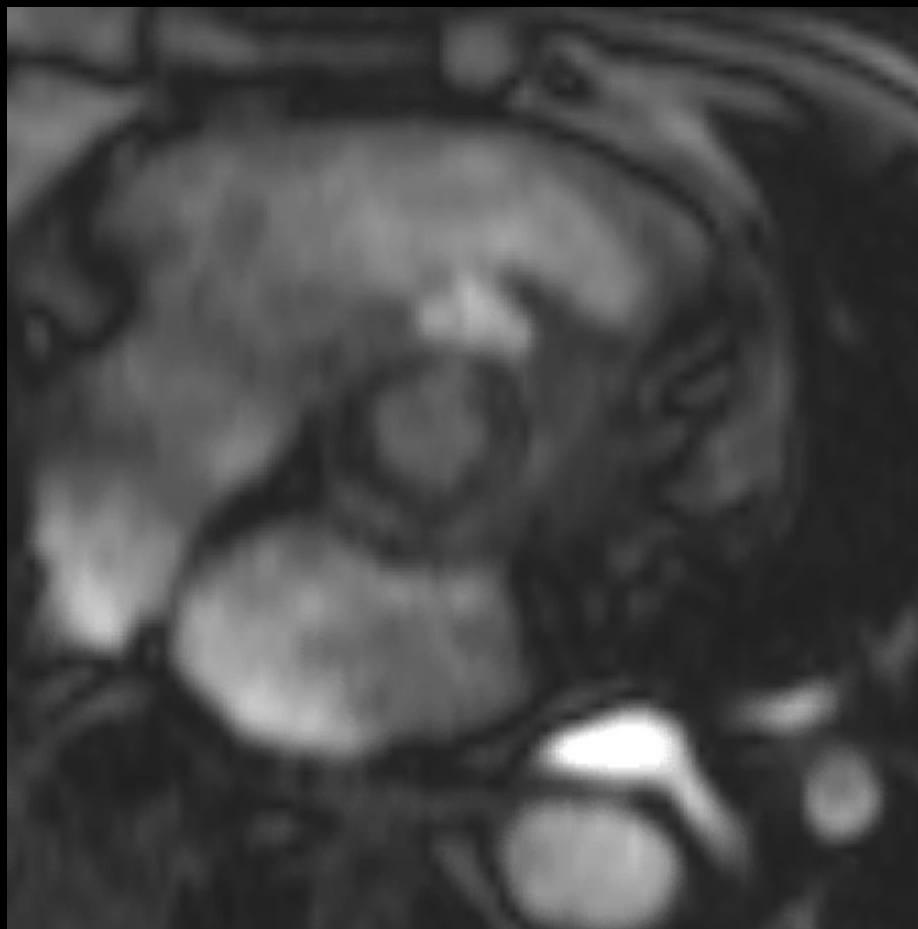
Aortic prosthesis leakage
