Leaks paravalvolari

Cenni di riparazione chirurgica

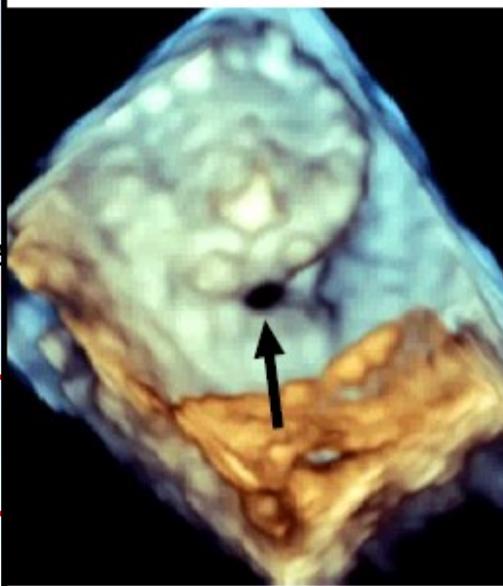
Round

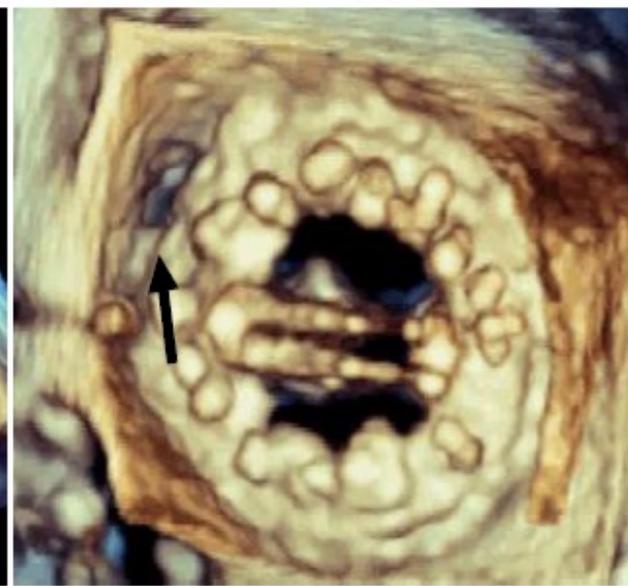
oval

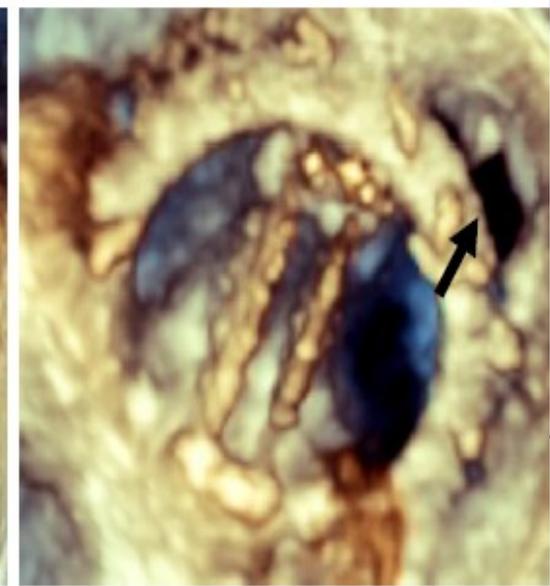
crescentic

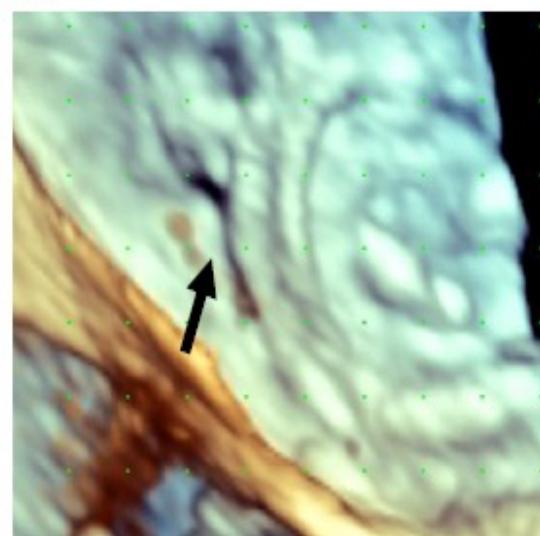
Slit-like

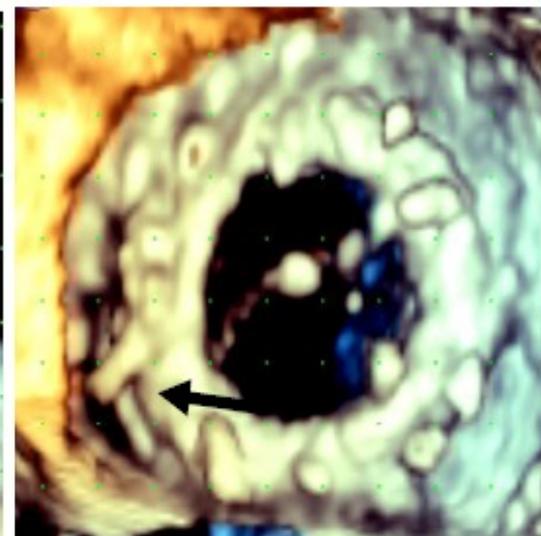
tunnel shaped PVL.

Crescentic cutting edge

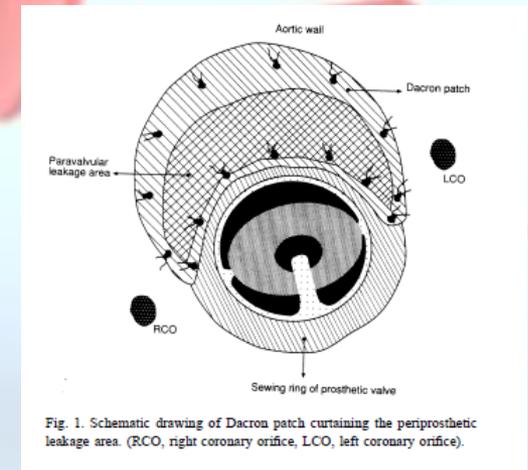
Fig. 1. Schematic drawing of Dacron patch curtailment the periprosthetic leakage area. (RCO, right coronary orifice, LCO, left coronary orifice).

Riparazione con Patch

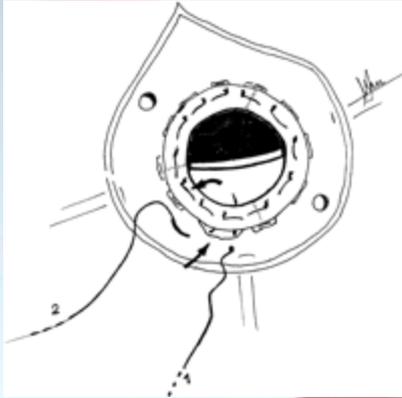
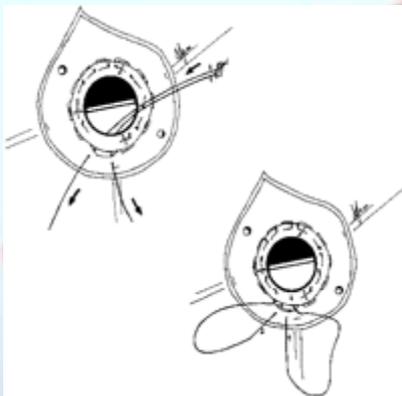
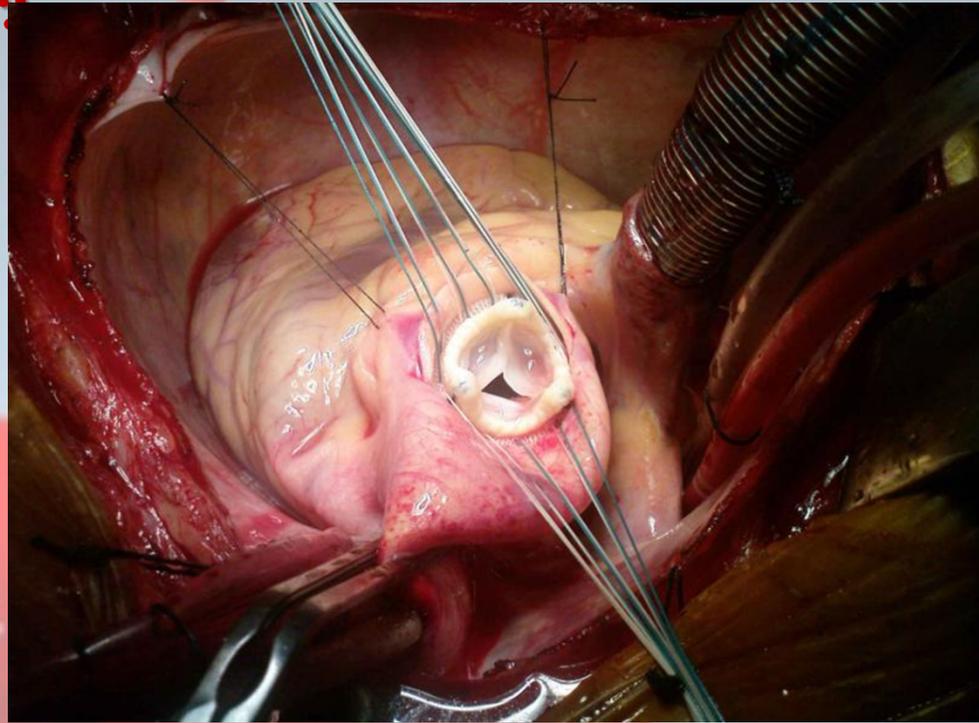
La tecnica richiede **punti intrecciati 2-0 su doppio ago**. Ogni ago è passato **attraverso l'annulus aortico dall'alto verso il basso**, poi **in direzione del ventricolo** e quindi nuovamente e delicatamente attraverso la protesi (Fig. 1). Dopo aver passato il **primo ed il secondo punto di sutura**, entrambi vengono **fissati su pledgets** (Fig. 2). Questo assicura che le suture siano saldamente ancorate al tessuto sottovalvolare. I restanti punti di sutura sono passati attraverso l'anello della protesi valvolare.

Questa tecnica chirurgica non è valida per protesi meccaniche di piccolo diametro (17 e 19 mm).

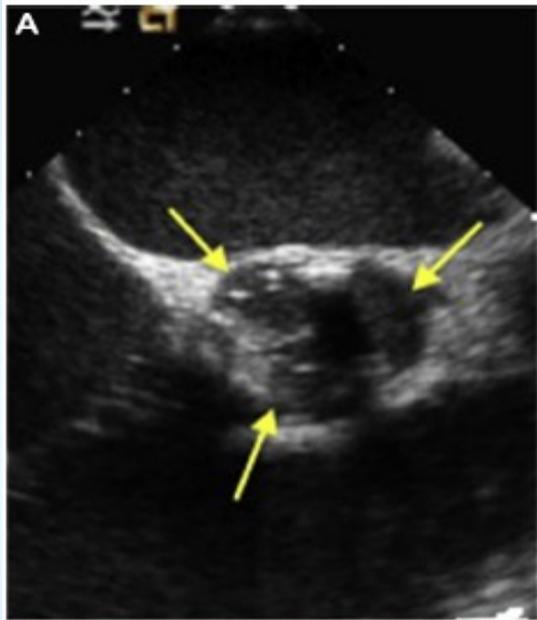
Figure 2 Transesophageal echocardiographic short-axis view with zoom of the aortic valve (**A**) showing echodensities on non-flow surface of the valve (yellow arrows), confirmed as thrombi on the explanted valve (**B**, black arrows). The flow side of the valve was unremarkable (**C**). Culture of the valve grew *P acnes*, illustrating that a thrombosed valve may also be infected.
